ENGM224
Geotechnical Engineering 2
Rock Slope Engineering Assignment

Sam Hobbs

April 15, 2013

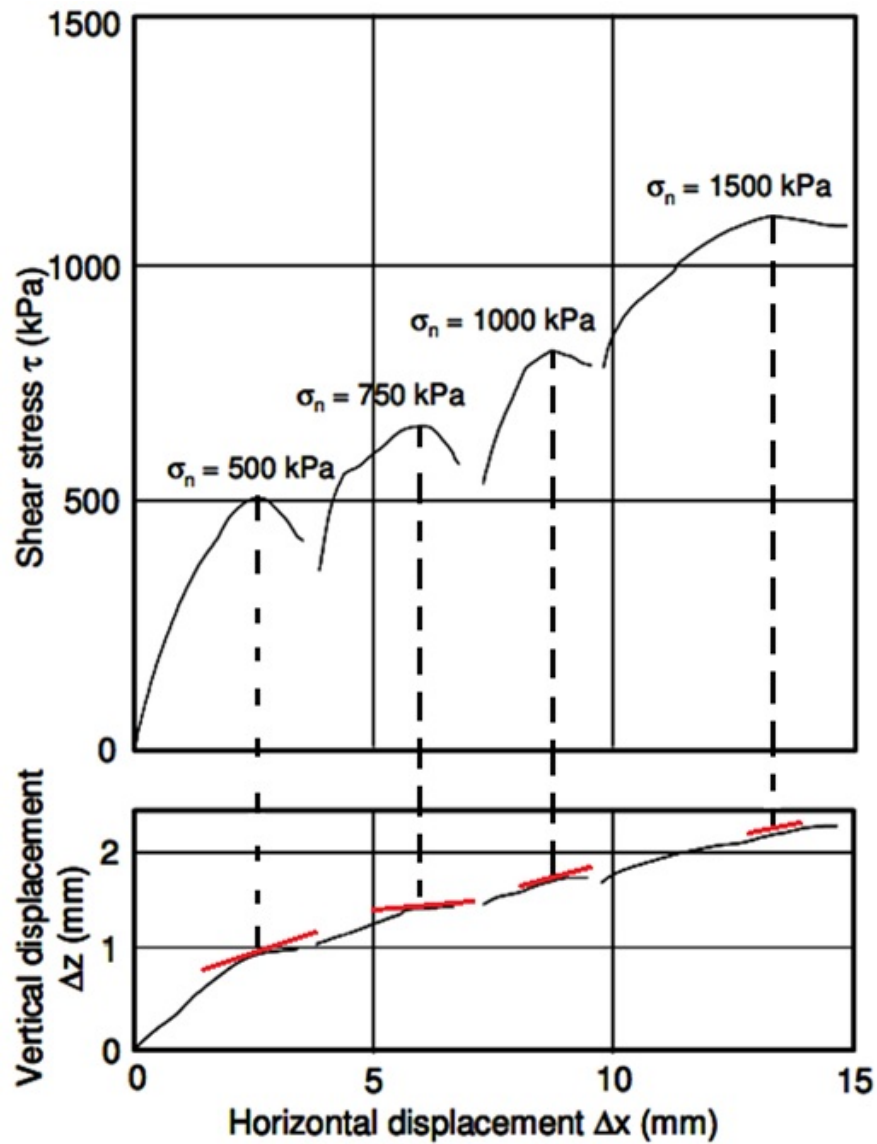
Figure 6: Results from a multi-stage shear box test on discontinuity samples.

The results from a multi-stage shear box test on discontinuity samples is shown in figure 6 on the next page. Initially, discontinuity surfaces have a peak friction angle of $\phi + i$. According to Wyllie and Mah (2005), if the dilation component is removed, the residual strength of the rock mass can be calculated - this is achieved by recording the horizontal and vertical displacements at peak shear stresses and converting them into i :

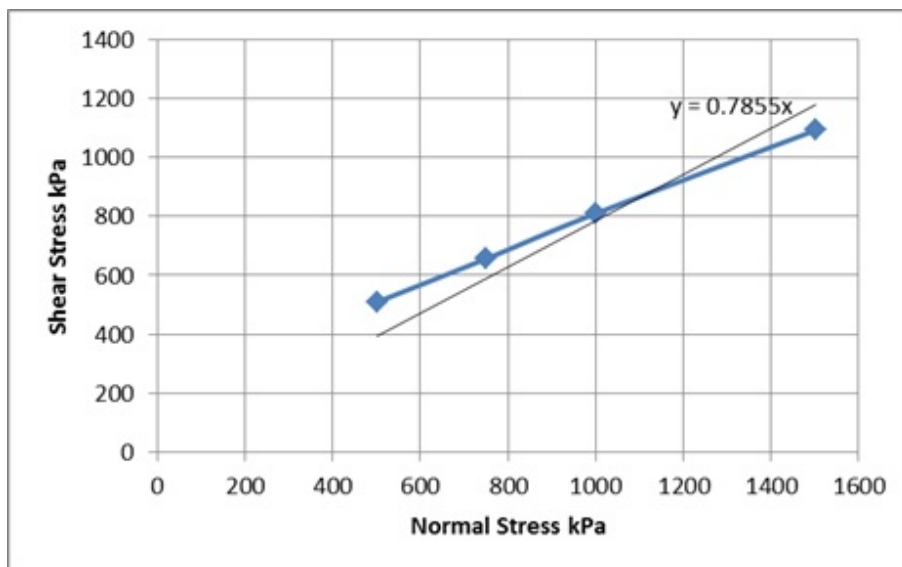
Figure 7: Modified normal stress vs modified sear stress for determination of ϕ .

The angle of friction was then calculated using simple trigonometry and figure 7 on page 9 to be 38°

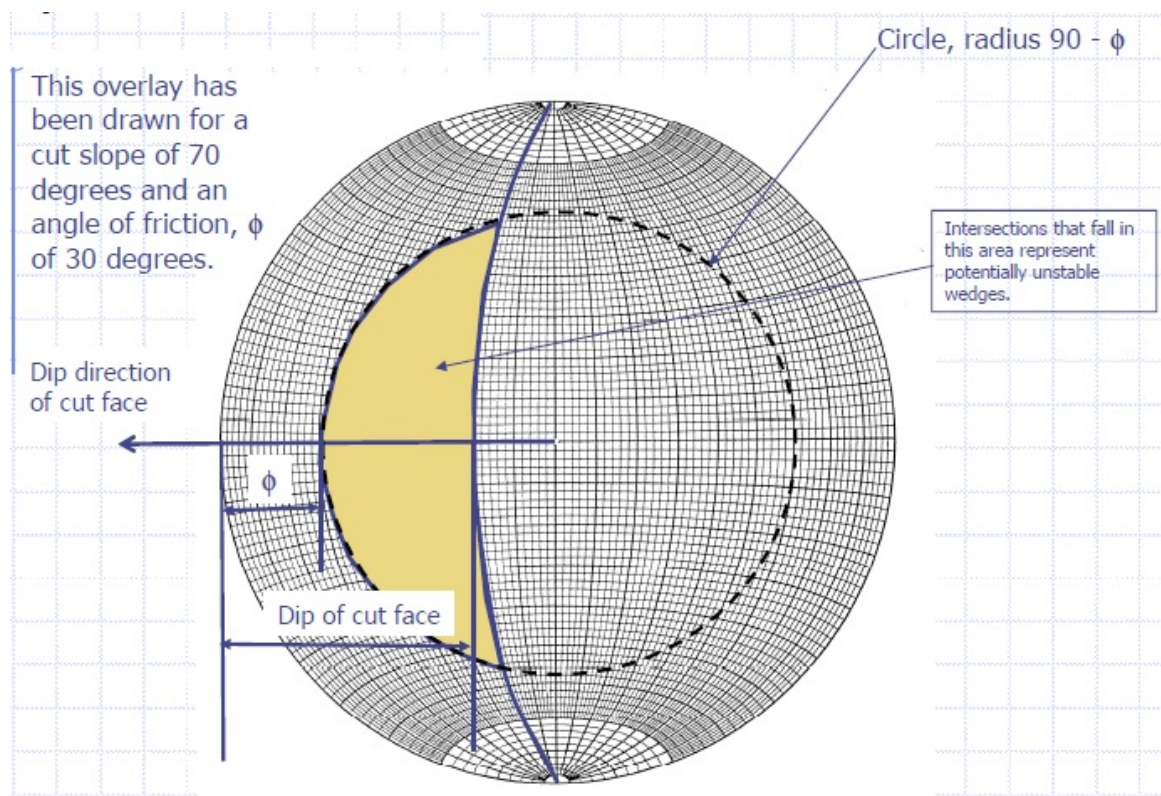
Figure 12: Construction of an overlay for checking wedge failure (M. Matthews, 2012a).

Wedge failure is a risk when there are two intersecting discontinuities at the necessary dip and dip directions to form a wedge whose line of intersection faces downwards into the cut face (figure 11 on the following page). To check for wedge failure, multiple overlays were constructed based on figure 12 on the next page.

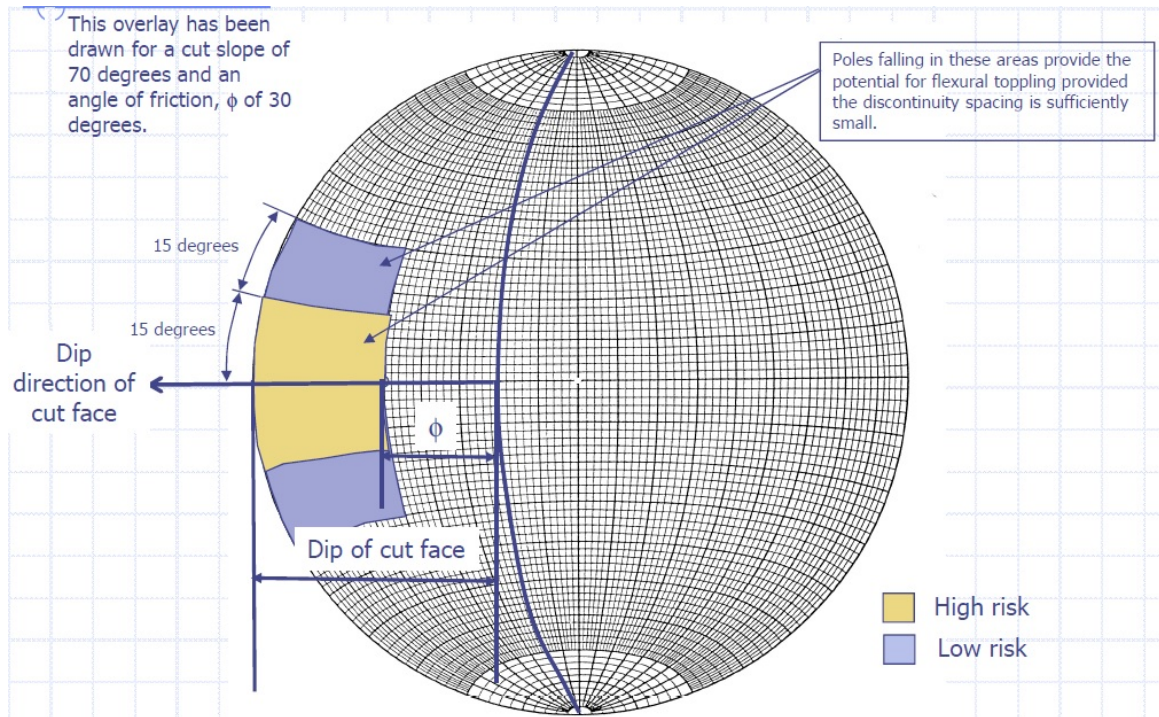
Figure 20: Construction of an overlay for checking flexural toppling failure (M. Matthews, 2012a).

Toppling failure is a risk when strong rock contains discontinuities with a steep dip angle and a dip direction facing into the cut face (figure 19). To check for toppling failure, multiple overlays were constructed based on figure 20 on the next page and figure 21 on the following page. Because the two types of toppling failure can both be checked using an overlay for block toppling, these are the only overlays that have been constructed. *Block-flexure toppling has not been checked in this analysis.*

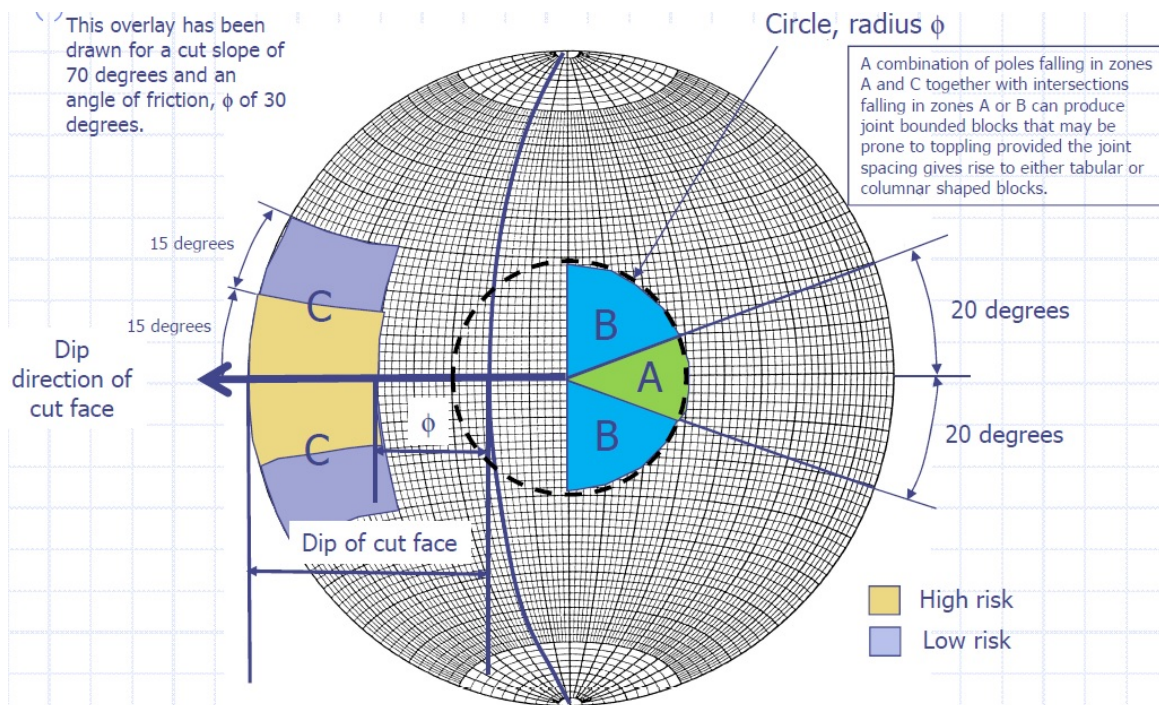
Figure 21: Construction of an overlay for checking block toppling failure (M. Matthews, 2012a).
